施工10年後
再施工前の未施工部と施工部の比較
4月撮影

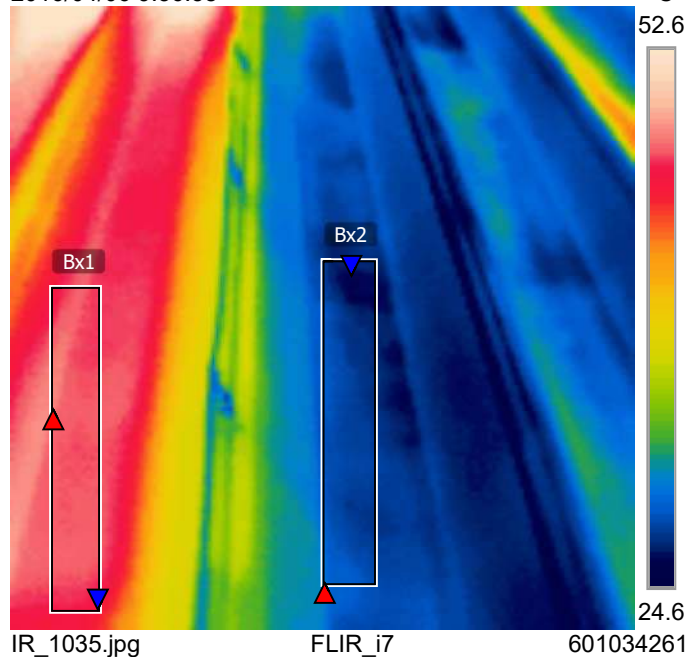
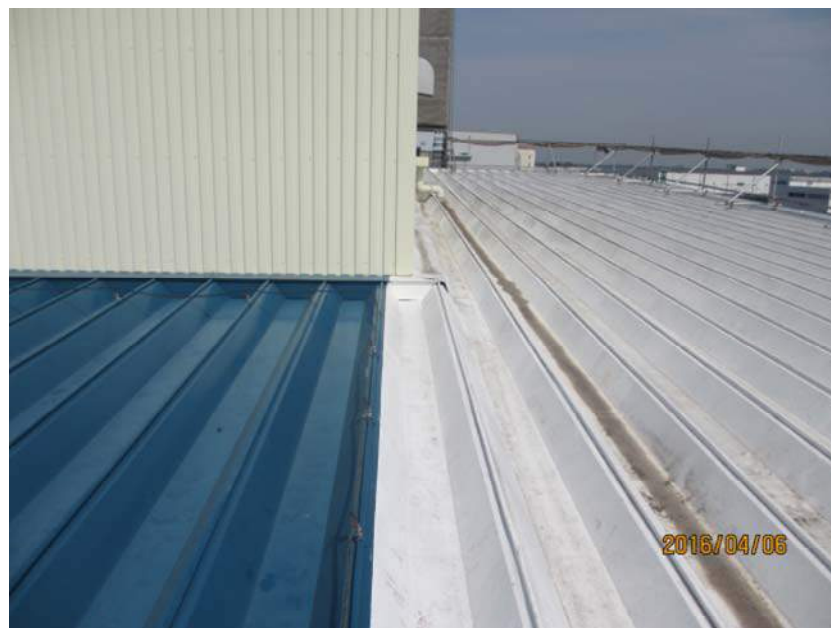
IMG_2611.JPG

施工10年後
再施工前の未施工部と施工部の比較
4月撮影

Bx1	Max	48.8 °C
	Min	46.1 °C
	Average	47.7 °C
Bx2	Max	30.1 °C
	Min	25.9 °C
	Average	27.8 °C

未施工部平均47.7°C
10年前施工部平均27.8°C
温度差19.9°C

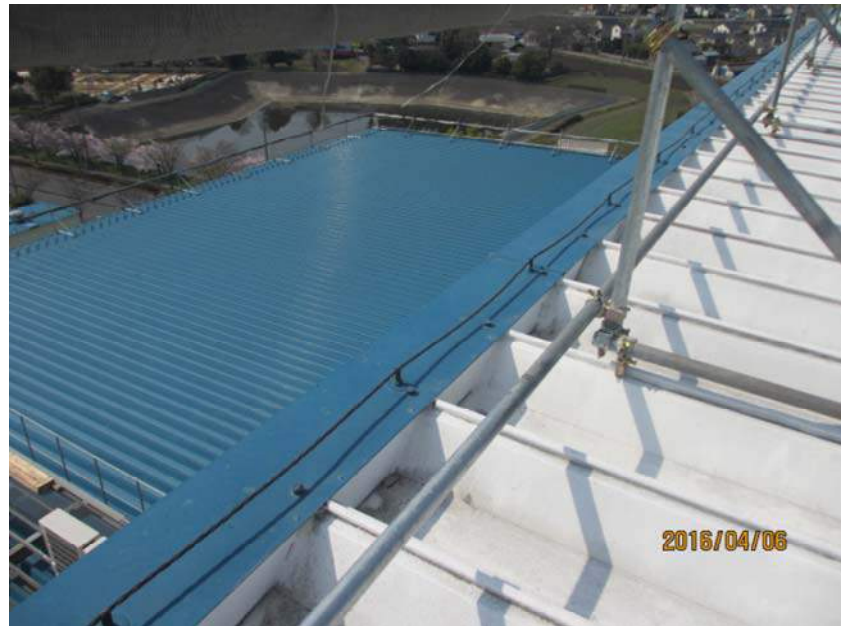
IMG_2612.JPG

Bx1	Max	48.7 °C
	Min	46.1 °C
	Average	47.4 °C
Bx2	Max	36.3 °C
	Min	31.6 °C
	Average	34.6 °C

未施工部平均47.4°C
10年前施工部平均34.6°C
温度差12.8°C

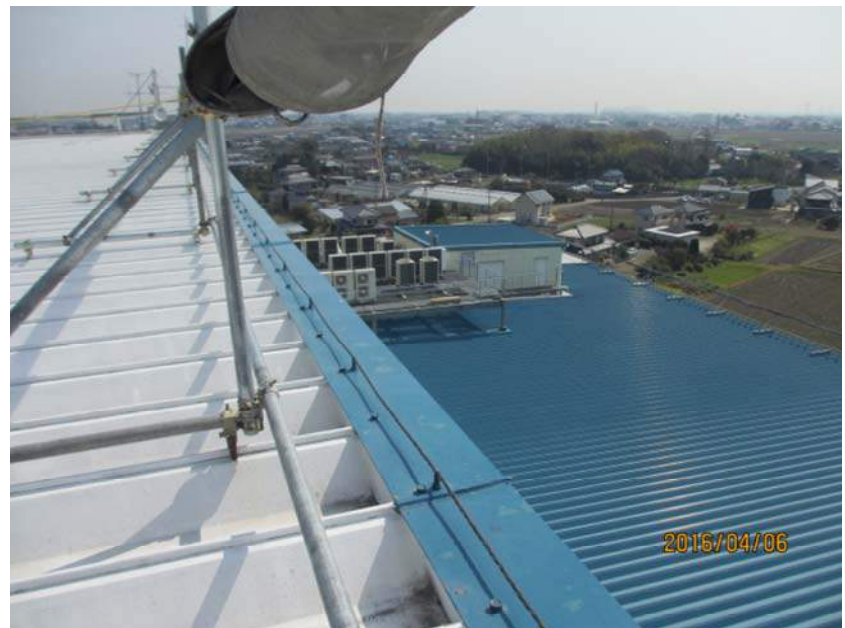
IMG_2619.JPG

施工10年後
再施工前の未施工部と施工部の比較
4月撮影

Bx1	Max	41.5 °C
	Min	40.1 °C
	Average	40.9 °C
Bx2	Max	29.6 °C
	Min	27.3 °C
	Average	27.9 °C
Bx3	Max	46.7 °C
	Min	44.9 °C
	Average	45.8 °C

未施工部平均40.9°C

10年前施工部平均27.9°C

温度差13.0°C

10年前未施工部平均45.8°C

温度差17.9°C
